# Solving forming problems for 40 years

Adam Neupert\* highlights a selection of case studies where Quantum has worked with glassmakers to solve a variety of forming problems in the glass production process.

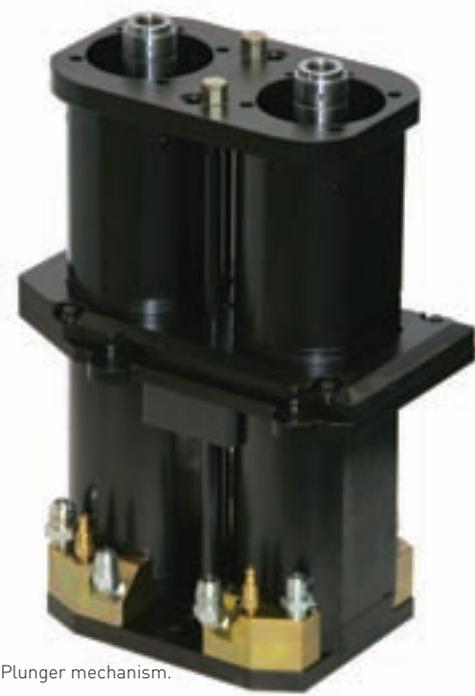
▲ Plunger mechanism.

from a gap between the cooler tube seal and the inner diameter of the Piston Rod. The leaking air entered the Piston Rod during Plunger up and made its way out of the Piston rod, up through the counter blow holes of the forming plunger and into the blank mould. When leaking air entered the blank mould, it created poor gob loading and unnecessary actions, such as excessive settle blow, to form a proper container.

**Corrective Action Taken:** Quantum supplied the manufacturer with its Plunger Mechanisms that include the Tube-within-a-tube (TWT) Cylinders. The TWT is a sealed forming system that eliminates air leakages in the forming process. The sealing technology within the TWT solved the air leakage problems that the manufacturer had struggled with for years. Gob loading improved and the related defects were eliminated.

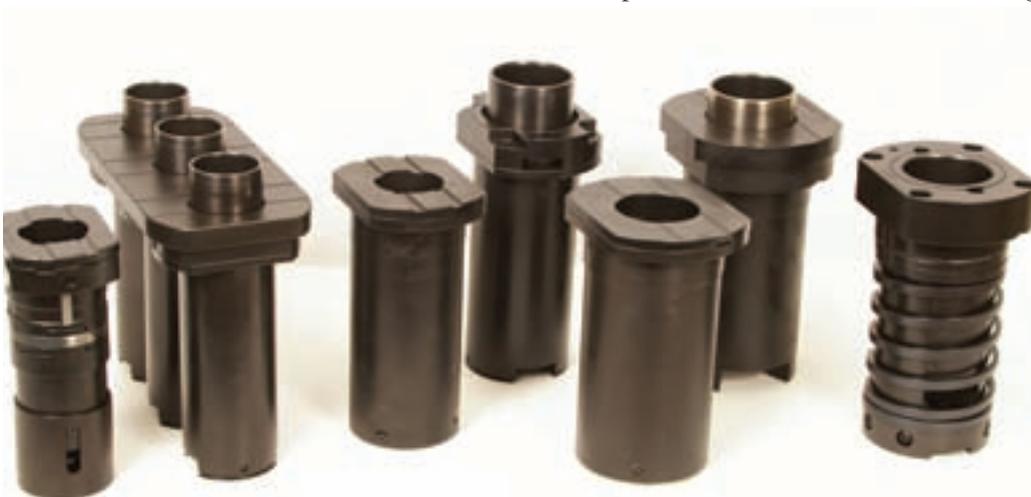
▲ Process equipment.
