Cord dispersal system reduces cat scratches on glass

In this article, Les Gaskell* introduces a cord dispersal system designed to eliminate cat scratches on glass by slow, continuous stirring.

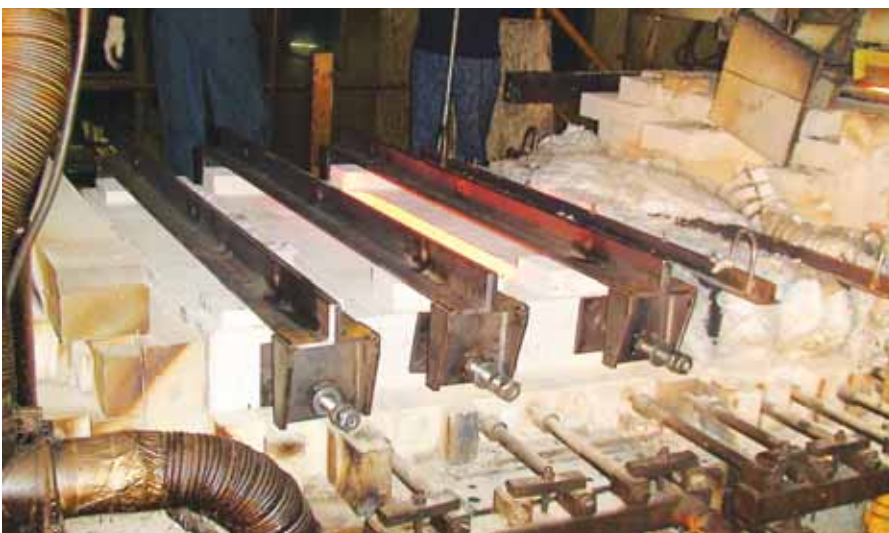
▲ Hot replacement of equalising section roof.

For existing forehearth designs, if a suitable access slot is not available, then the equalising section superstructure refractories must be replaced to provide the necessary stirrer access slot. This can be carried out while hot, during an extended job change or other machine stoppage such as a feeder spout change.

The replacement equalising section superstructure refractories are designed to match the existing design as closely as possible, while incorporating the necessary access slot for the stirrers to minimise the refractories that need to be replaced hot and thereby minimise downtime.

The superstructure refractories are supplied in PSR 333 material, which is suitable for hot installation. Suitable roof block lifting frames and temporary, lightweight, high-grade ceramic fibre roof block covers are supplied to assist with the hot replacement operation. The superstructure bracing steelwork incorporating the necessary support mountings for the stirrer mechanism is installed at the same time. Typical production downtime would be four to eight hours, depending on the quantity of refractories that have to be replaced.

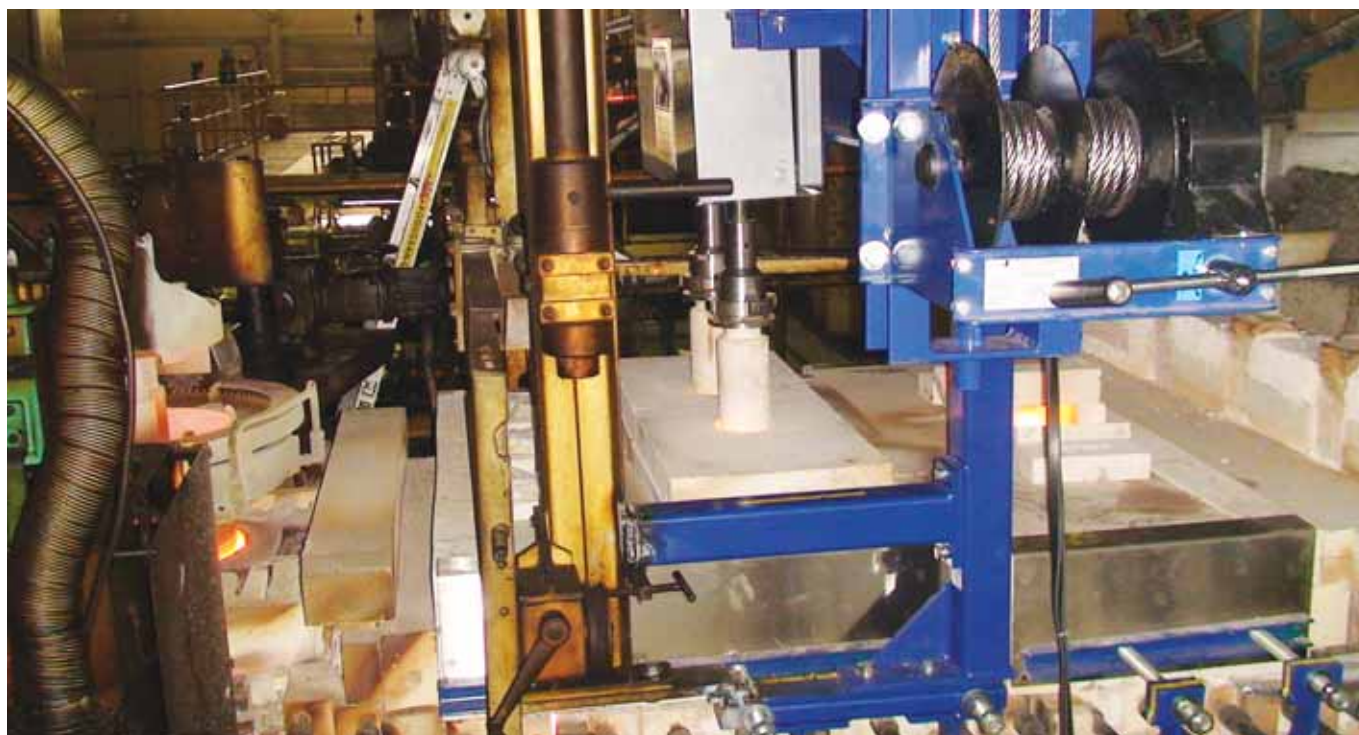
▲ Cord dispersal stirrer system.

The PSR cord dispersal system uses twin counter rotating and bladed, paddle type stirrers installed in the equalising section.

The paddle stirrers have left and right-hand blades and are rotated in opposite directions to lift glass off the channel base, as well as move glass from

the channel sidewalls to the centre and towards the feeder spout. The left-hand bladed paddles are rotated anti-clockwise while the right-hand bladed stirrers are rotated clockwise to lift the glass. The stirrers are operated as close to the channel base as possible with the paddle blades at 90° to each other and configured to overlap and cover as much of the channel base as possible to provide efficient stirring across the channel base. The exact stirrer design and configuration for each installation depends on the channel width, profile and depth at the required stirrer location.

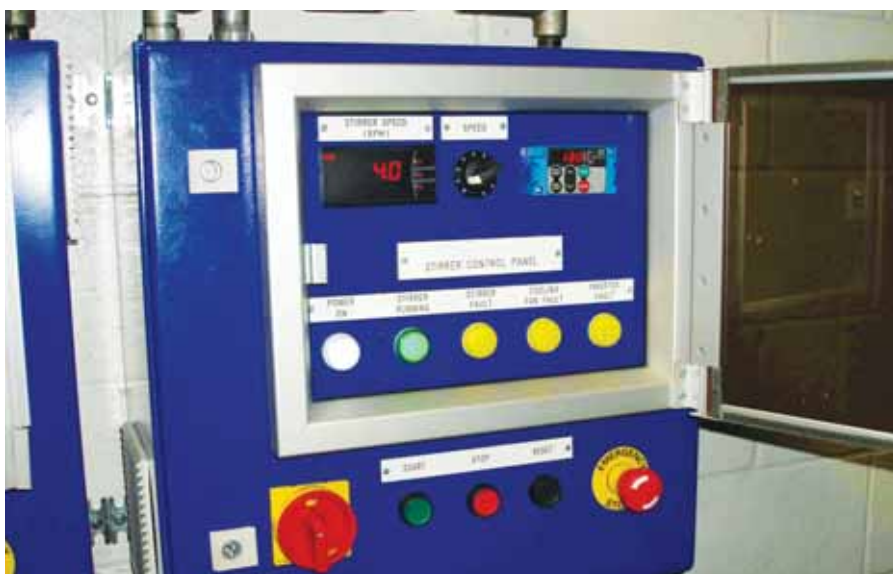
▲ Stirrer control panel.
